Letter Health Consultation

Hamilton Centerpoint Site Eatonville, Pierce County, Washington

March 17, 2014

Re: Letter Health Consultation
Preliminary Health Assessment
Hamilton Centerpoint Site
Eatonville, Pierce County, Washington

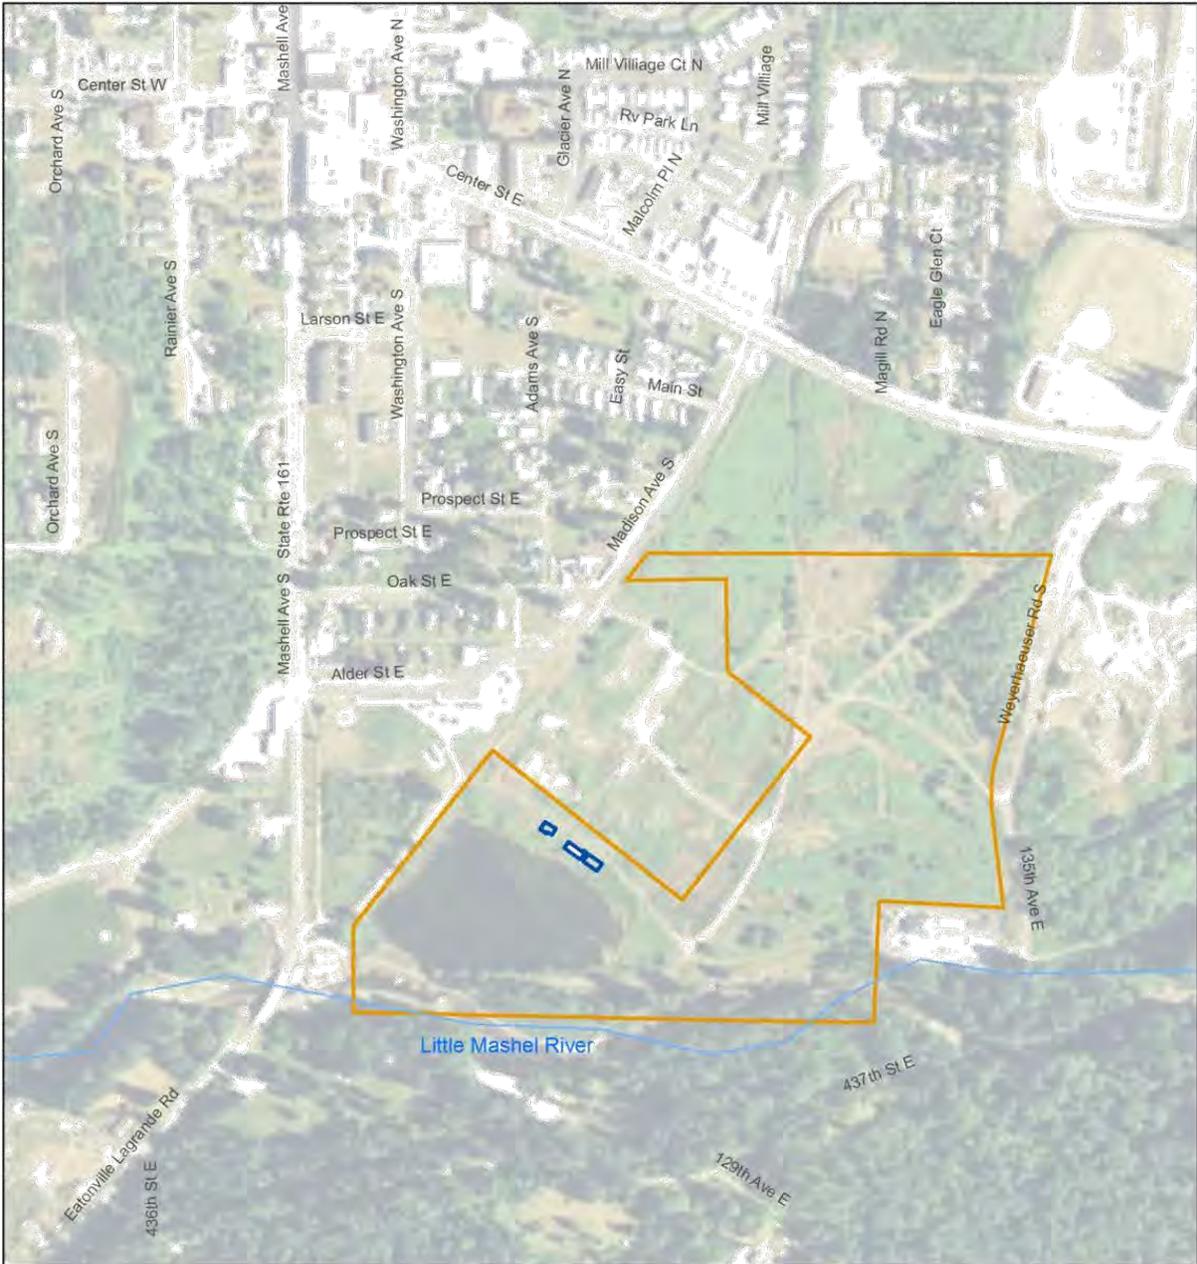
Figure
 1

The Hamilton Centerpoint site is an approximately 33-acre vacant parcel (parcel number 0416231052) located at 349 Madison Avenue South in Eatonville.(3) The property is bordered

by Madison Avenue South and vacant land to the west, vacant land to the north, Weyerhaeuser Road South and Town of Eatonville Water Department property to the east, and the Mashel River to the south (Figure 1).

Vicinity Map
 Hamilton Centerpoint Site
 Eatonville, WA

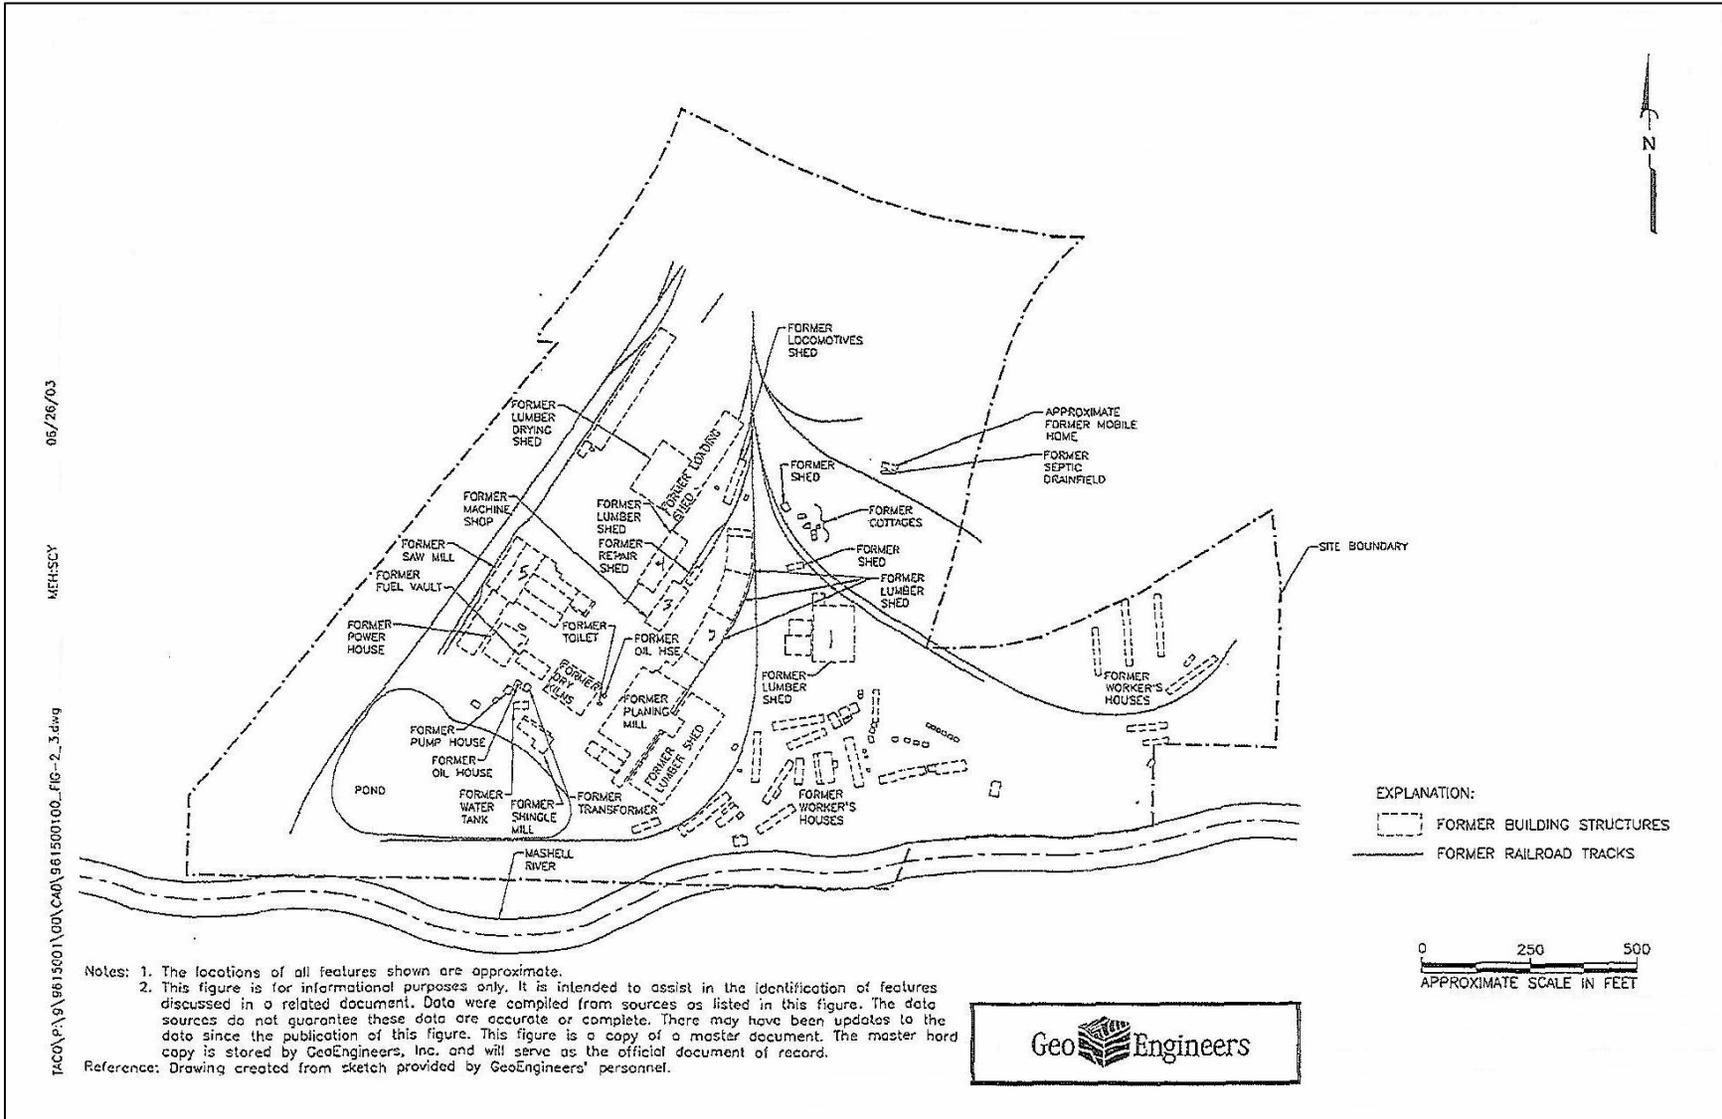
Figure 2: Former Eatonville Lumber Company(4)

The Hamilton Centerpoint site is part of the approximately 63-acre former Eatonville Lumber Company property, which included a saw mill and related structures. The lumber company operated from about 1907 to 1954. Dry kilns, railroad tracks and spurs, railroad round house, oil houses, machine shop, garages, and a repair shed appear to have been part of the lumber company operation (Figure 2). The lumber company reportedly did not treat their wood or wood products; however, that information has not been verified. Between approximately 1960 and 1990, the former lumber company property was reportedly used as a chicken farm. Based on available information, it appears that a significant part of the lumber company and some of the chicken farm operation occurred on the Hamilton Centerpoint site.(4)

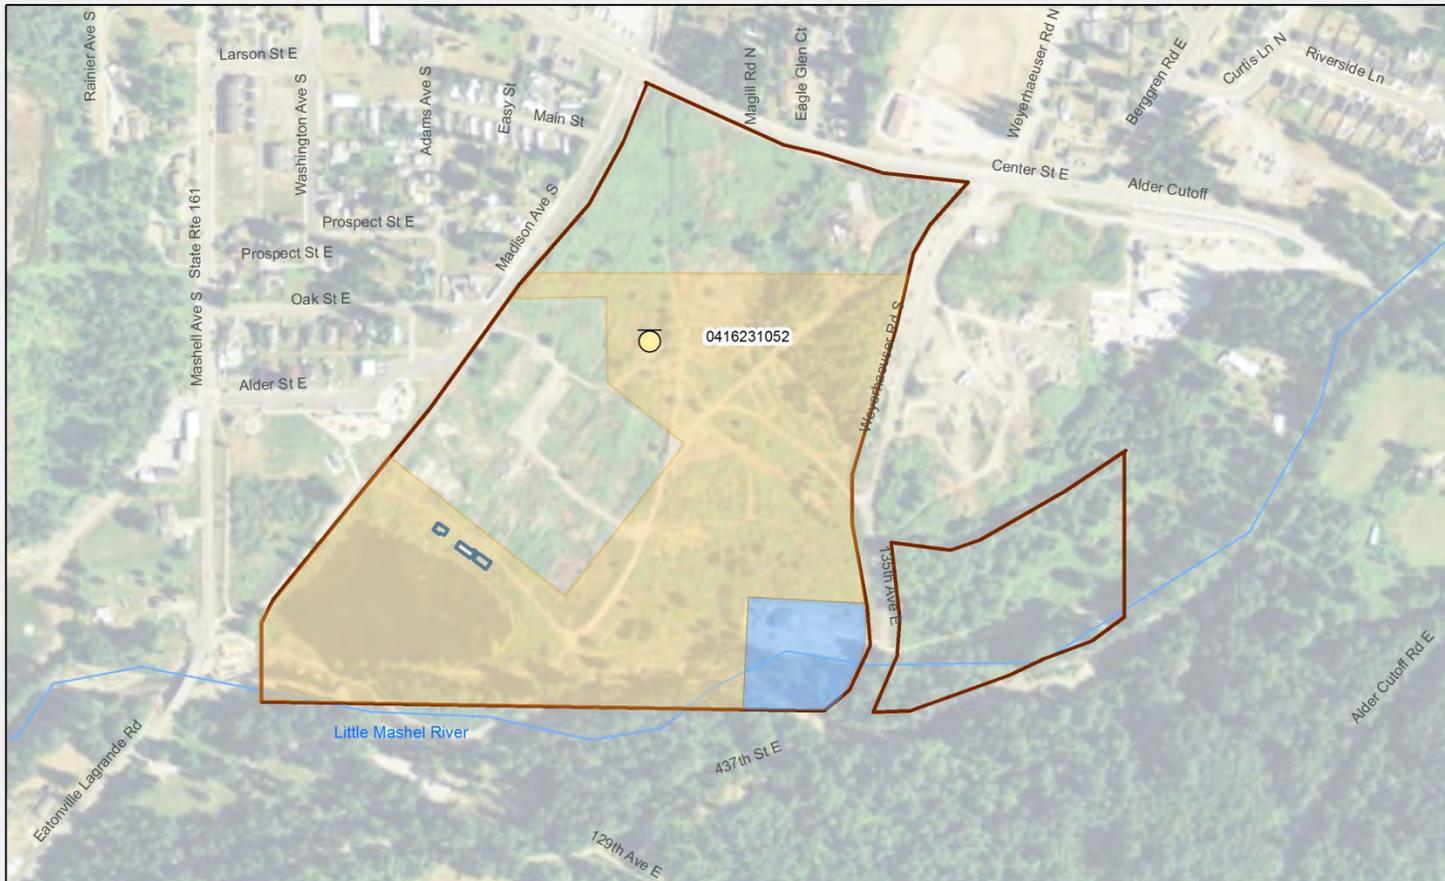
Hamilton Centerpoint Site Eatonville, WA	Figure 3
---	-------------

An underground storage tank (UST) containing bunker fuel was identified in the northwestern portion of the site in 2003 (Figure 3).(4) The UST, which was an approximately 14,000 gallon poured in-place concrete tank, was decommissioned and demolished in 2010. At the time of the decommissioning, the UST contained approximately 2,765 gallons of bunker fuel that was classified as “bunker C.” It was assumed that the bunker fuel was used to fuel locomotives at the former lumber company.(6) Diesel and oil range hydrocarbons were found in the soil in the vicinity of the former UST and visible petroleum was observed in groundwater.(5;6) However, no estimate of the amount of petroleum that might have been released to the soil or groundwater has been made.

The former UST was located approximately 1,100 feet northeast of some of the Town of Eatonville’s public water supply wells (Wells 1, 2, 6, and 7) (Steve McKasson, Eatonville Water Department, personal communication, February 14, 2014) and within the town’s well head protection area.(4;6). These four water supply wells are located on Water Department property (Figure 3) and range in depth from 38 to 74 feet.(7) Some Town of Eatonville abandoned/emergency wells (Wells 3, 4 and 5) are located approximately 1,500 feet east of the other four wells (Steve McKasson, Eatonville Water Department, personal communication, February 14, 2014).

Because the site poses a potential threat to groundwater and some of the Town of Eatonville's public water supply wells, DOH recommends additional investigation including monitoring well installation and testing.
